80% DESIGN - NOT FOR CONSTRUCTION

| VERIFY SCALE! | REVISIONS | | | | | DRAWN BY: CRH | | PROJECT NUM | JMBER | | | |
|--|---|--|---|---|---|---|---|---|---|---|---|---|
| | NO. | DESCRIPTION | DATE | BY | | | 3011 Palmer St. | | DSGN. BY: MDB | FRENCH CREEK RESTORATION IN FRENCH GULCH | 5002.004 |)4 |
| MODIFY SCALE ACCORDINGLY! | | | | | An Employee-Owned Company | | Fax: (406) 542-4801 | | BY: * * * | RESTORATION AREA 2 STA 28+50 TO 42+76 EARTHWORK | C-1 | 6 |

| VERIFY SCALE! | REVISIONS | | | | | DRAW | DRAWN BY: CRH | | PROJECT NUMBER | | |
|---|---|--|---|---|---|---|---|--|---|---|---|
| MODIFY SCALE ACCORDINGLY! | | | | | An Employee-Owned Company | | Fax: (406) 542-4801 | | BY: * * * | RESTORATION AREA 3 & RESTORATION AREA 4 EARTHWORK | $C_{-}17$ |

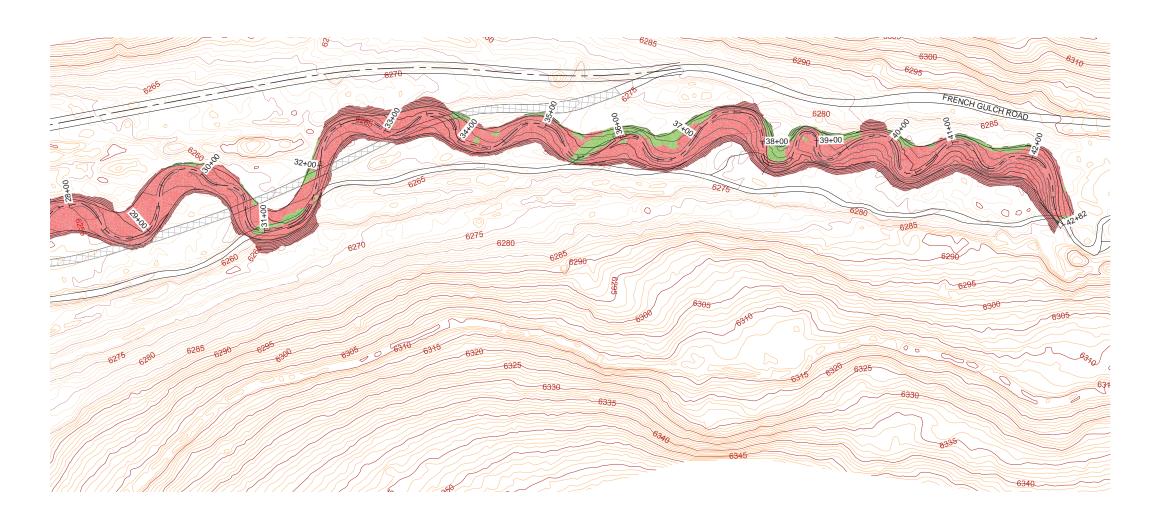
- SURFACE CONTOURS CREATED FROM DIGITAL TERRAIN MODEL BY LIDAR
 METHODS FROM ROBERT PECCIA & ASSOCIATES, INC.
 HORIZONTAL DATUM = NAD83 MONTANA STATE PLANE, VERTICAL DATUM = NAVD88
 CONTOUR INTERVAL = 1 FT.
 SOLID RED HATCH DENOTES AREA OF CUT.
 SOLID GREEN HATCH DENOTES AREA OF FILL.

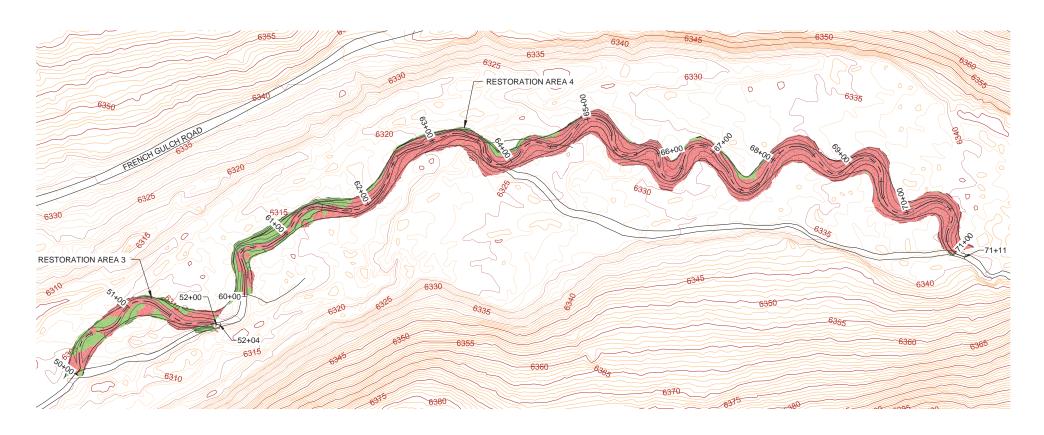
- SURFACE CONTOURS CREATED FROM DIGITAL TERRAIN MODEL BY LIDAR
 METHODS FROM ROBERT PECCIA & ASSOCIATES, INC.
 HORIZONTAL DATUM = NAD83 MONTANA STATE PLANE, VERTICAL DATUM = NAVD88
 CONTOUR INTERVAL = 1 FT.
 SOLID RED HATCH DENOTES AREA OF CUT.
 SOLID GREEN HATCH DENOTES AREA OF FILL.
